# #5 MINE-FAN HOUSE CUMBERLAND B C

## HERITAGE ASSESSMENT

2013 November 07  
JY13020

**FAN HOUSE #5 MINE  
CUMBERLAND B C**

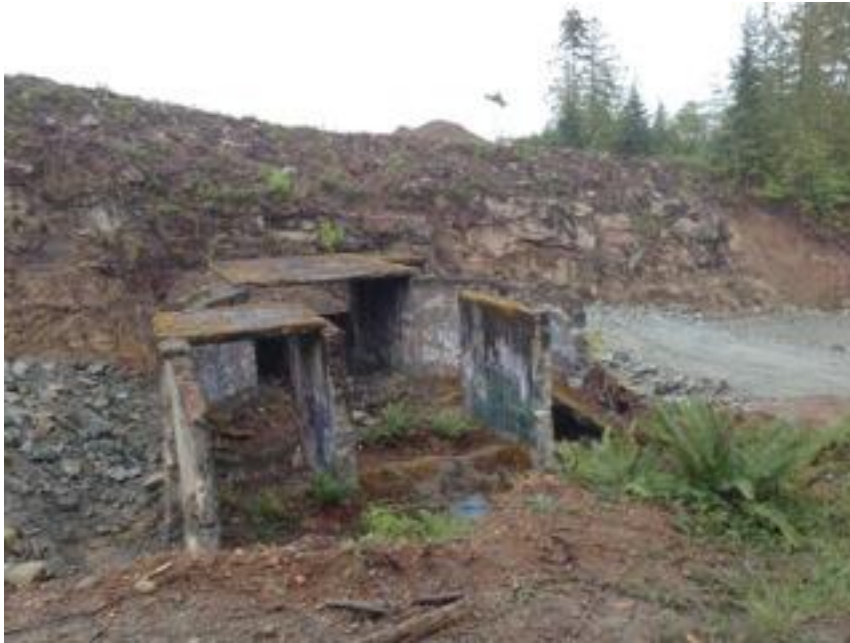
2. View from west across canyon showing concrete fin walls with collapsed wall & roof to the south (right)

v) Over two sections of the concrete wall structure are reinforced concrete “roof” slabs, and roof slab over the southwest rectangular has collapsed and is laying at approximately 60° in the space of the 7' wide, 10' high and 11'-4" long section where the original south wall has also collapsed. It would appear that this collapse is partly due to the presence of a +/- 29" diameter maple (recently removed). The pressure exerted on the concrete by the tree could have aggravated it and partially caused its collapse.

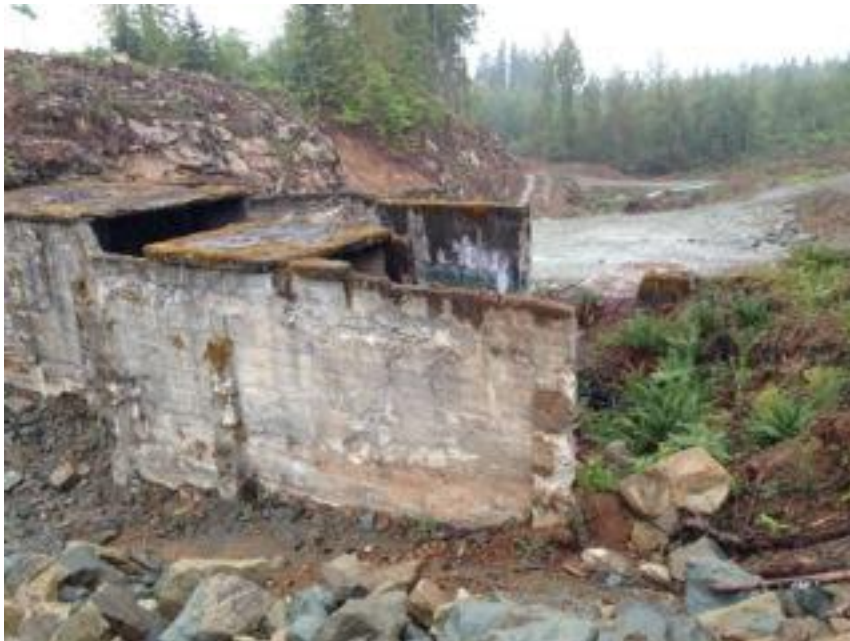
3. From north looking down canyon with north exterior wall

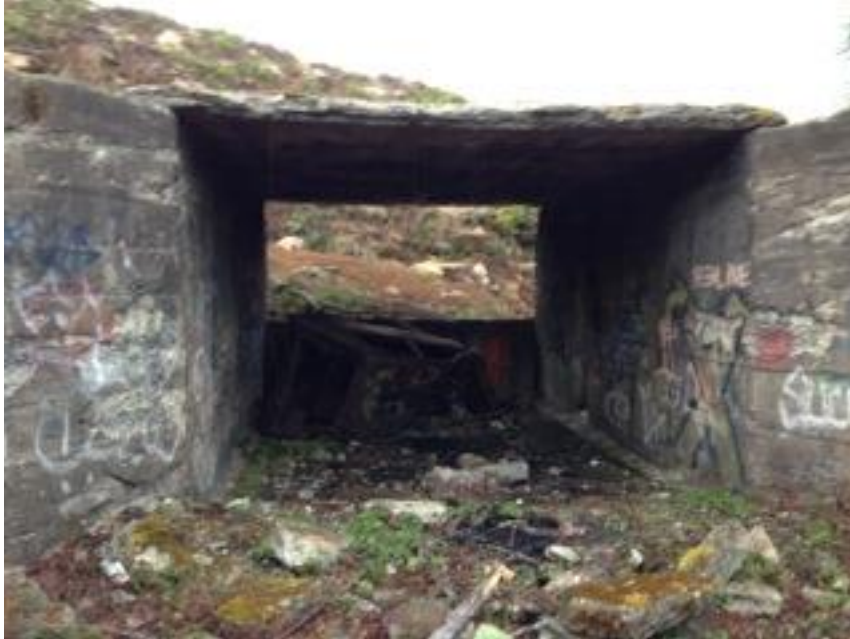
ii) It is assumed that the wider section was for two air intakes with the central area for fan equipment. From these two sections of air entered the 14' wide, 21'-6" long and 10' high rectangular section which, at its east end was reduced in size to 14' wide and 6' high.

4. East 14' wide section looking towards horizontal mine shaft

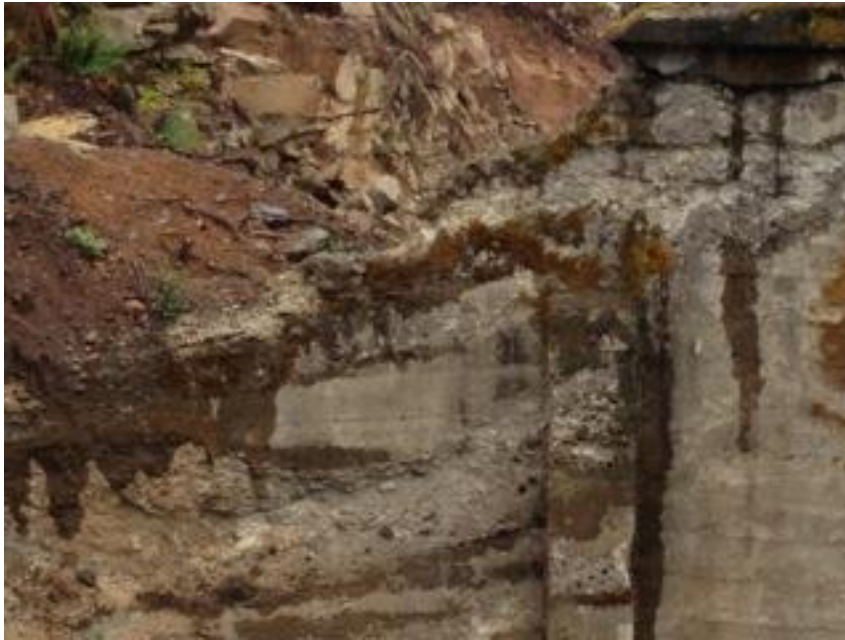
5. Concrete fin wall to north of blocked horizontal mine shaft  
iv) As the air duct and shaft to #5 Mine has been blocked off, it is not possible to observe the exact configuration of the connecting of ducts from the Fan House to the mineshafts.

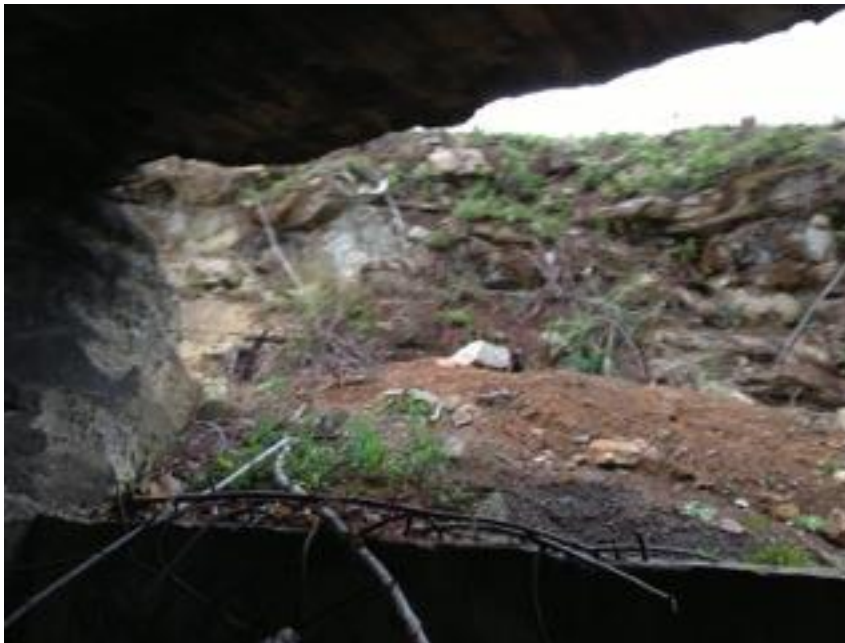
6. East towards blocked horizontal mine shaft

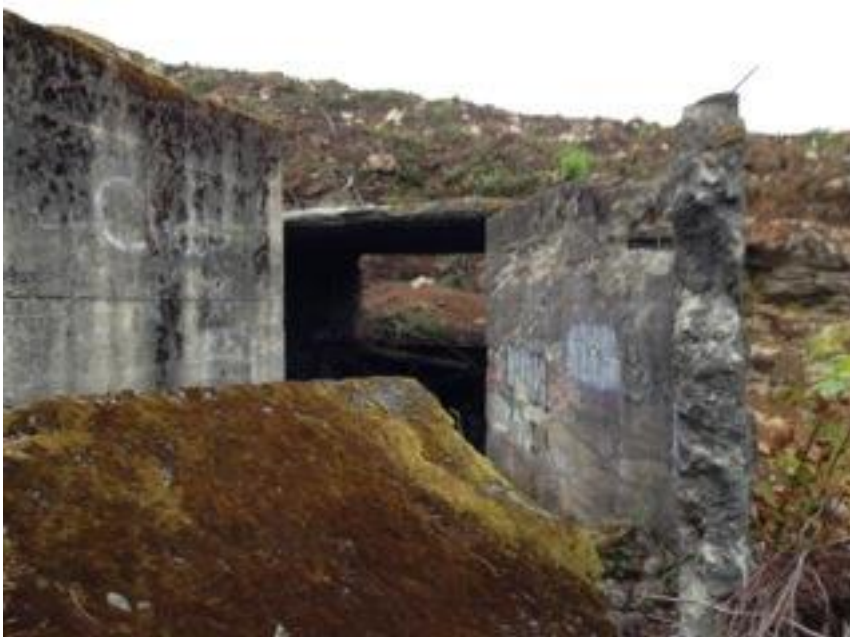
7. Collapsed roof section over south bay

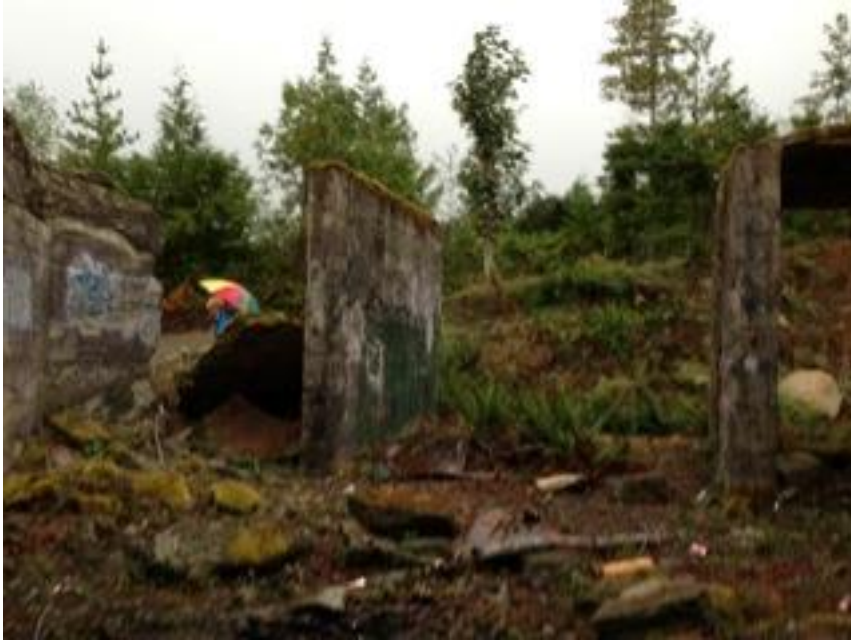
8. Fin walls looking west with collapsed roof slab to left

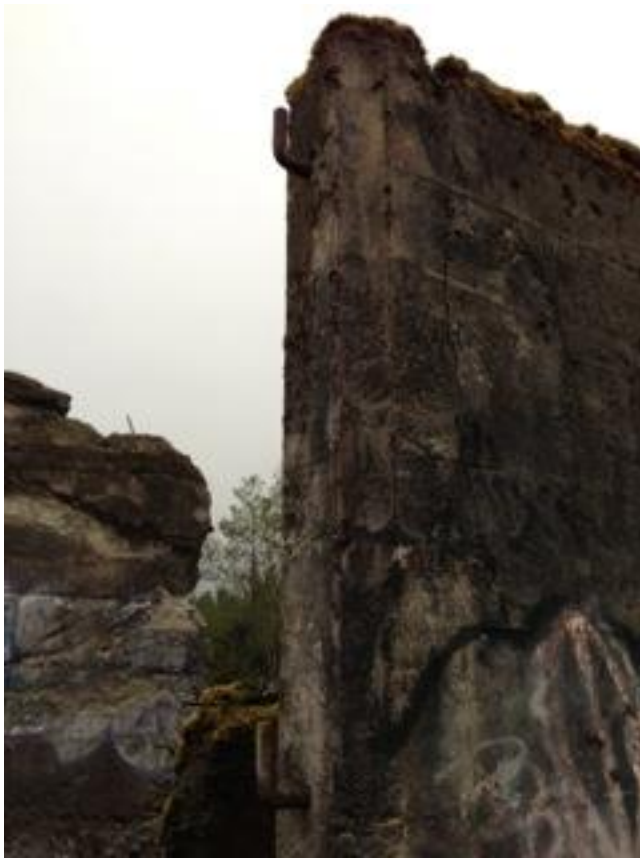
vi) The two 13" wide concrete fin walls to the western most section have two sets of three 1¼" diameter metal hinge pins cast into their east faces which could have been used to support some sort of doors or shutters.

9. Fin wall showing two metal hinges

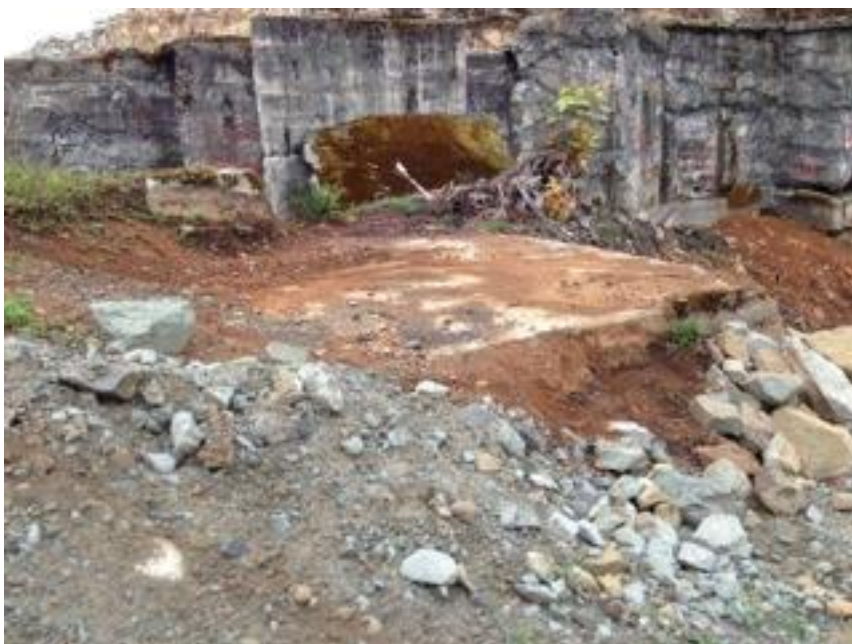
vii) In addition to the remaining concrete structure of the Fan House are two other concrete elements. First, a large approximately 10' x 12' concrete slab located to the southwest. Associated with this slab is a plinth approximately 3' x 2' and 2' high which is surmounted with 4# 1" diameter steel rods at each corner.

The above two elements could be interpreted as the floor slab of a wood building (structure) and the pier block the support for some form of electrical transmission pole. Most Fan Houses of this era were powered by hydro electricity and this house is likely to follow this pattern. In Appendix D is a photograph of part of the interior of the Fan House for #4 Mine. This shows a concrete structure and the scale of the electrical equipment.

10. Concrete slab to south of main structure

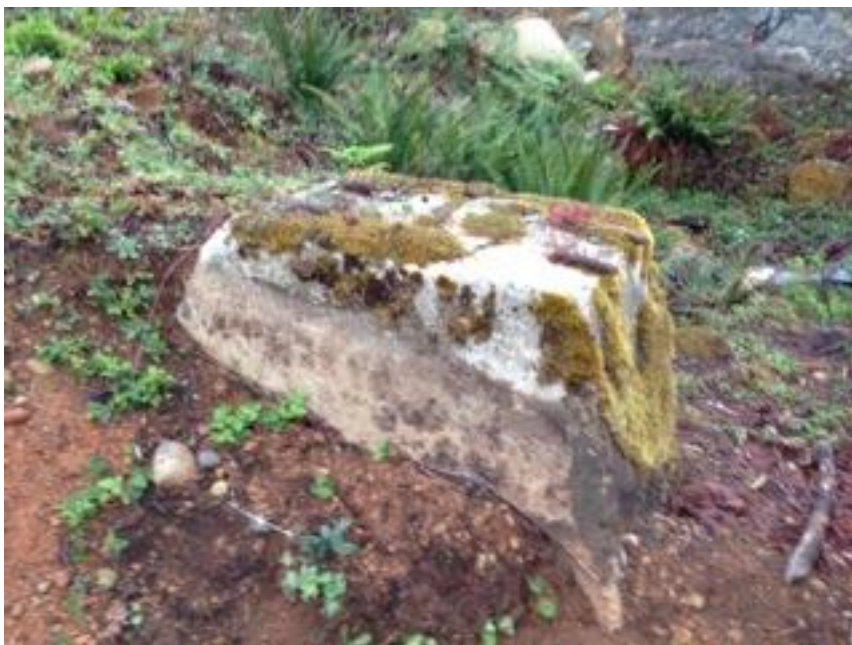
11. Foundation block for electrical power pole?

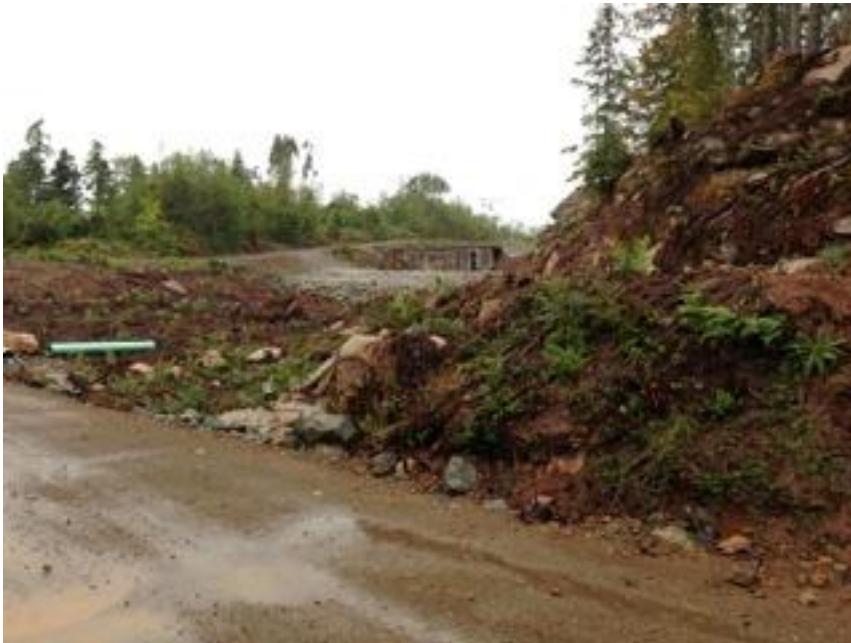
12. Approach into canyon from the south with Fan house in center

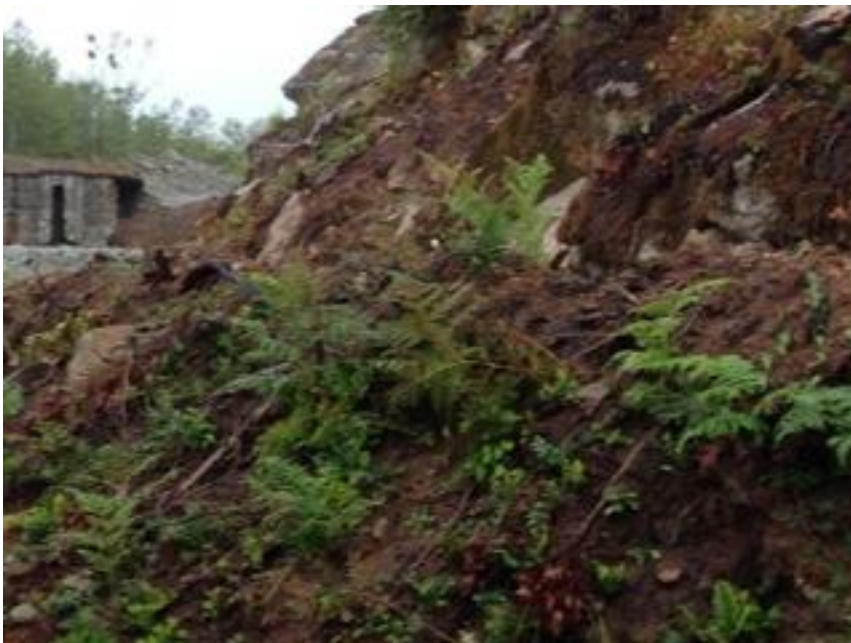
13. East side of canyon

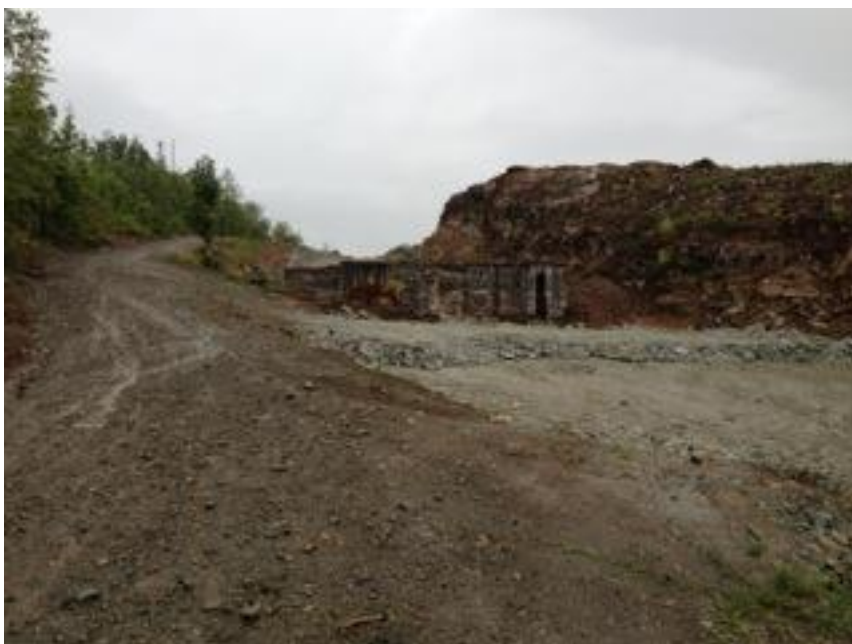
14. Canyon and Fan house from the south

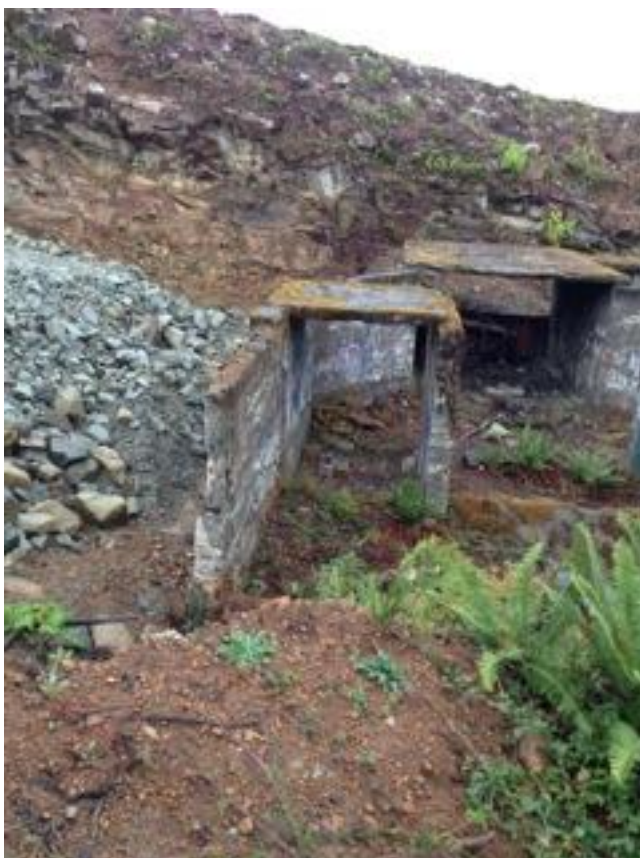
15. Looking across canyon to the east, note fill to left

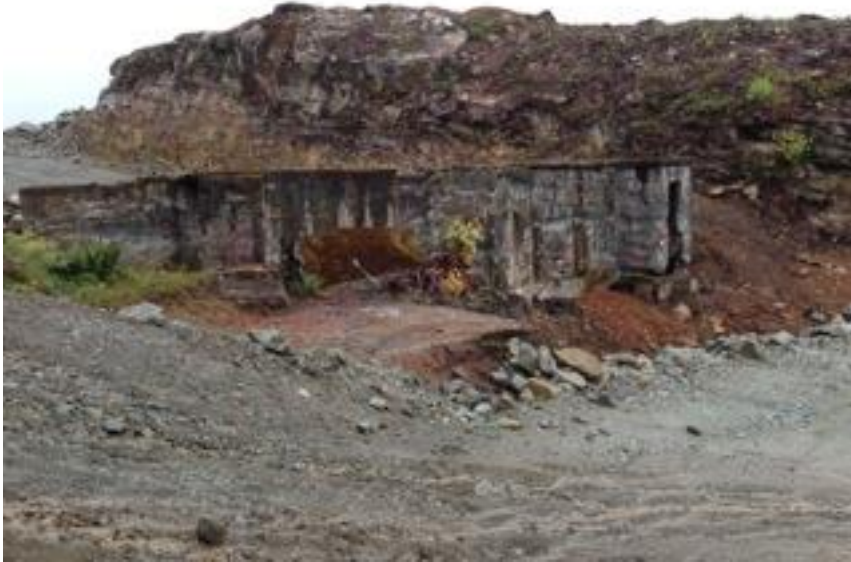
- i) All trees and vegetation have been removed from the canyon;

16. From the west all vegetation removed

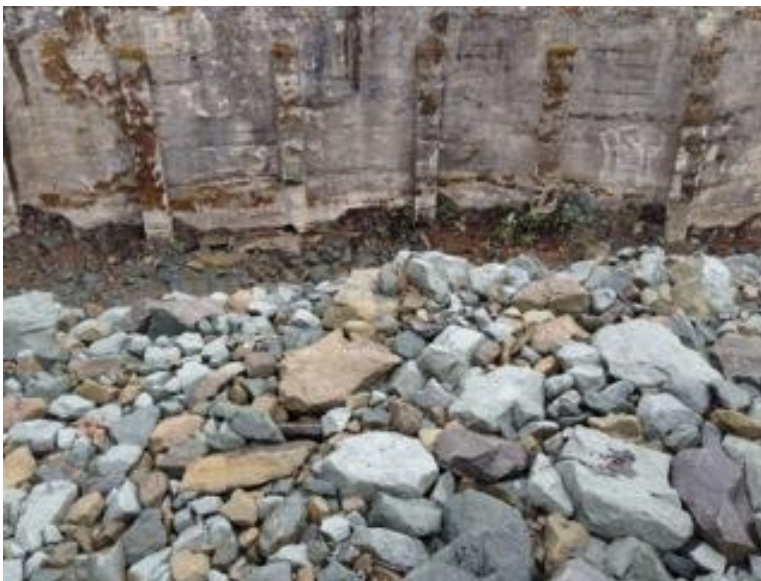
- ii) The grade at the base of the concrete structure has been undermined;

17. Exposed base of concrete foundation on north side

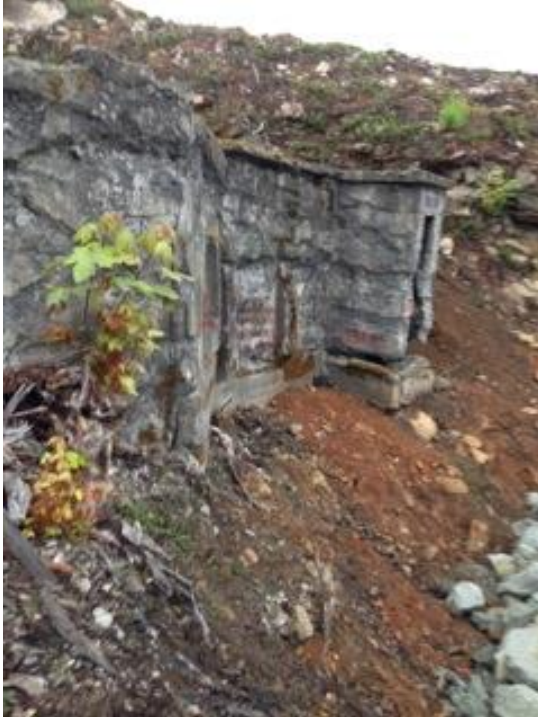
18. Undermining of concrete foundations on south side

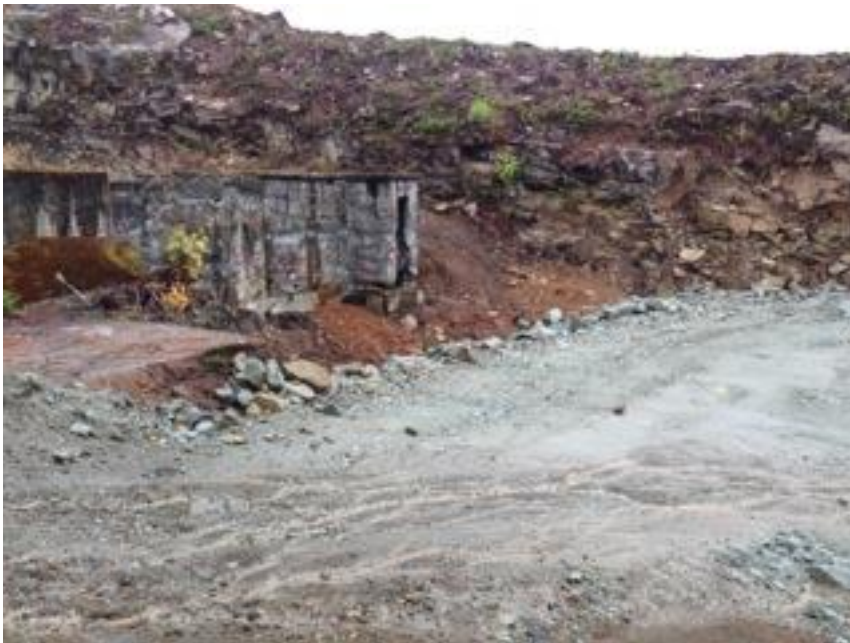
iii) A huge amount of blasted rock has been placed to both sides of the Fan House, which appears to be the bed for a future road.

19. Placement of blasted rock fill to south side of Fan house

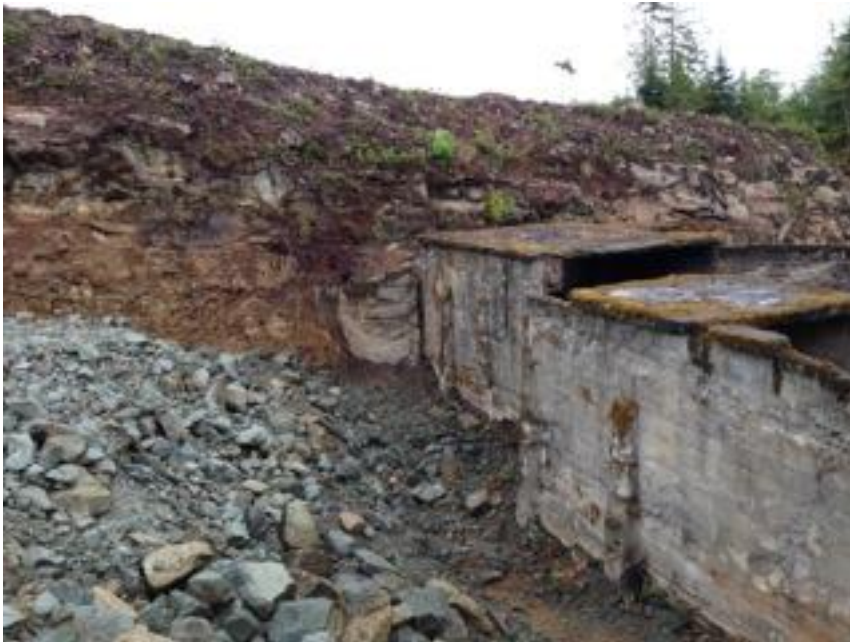
20. Placement of blasted rock fill to north side of Fan house

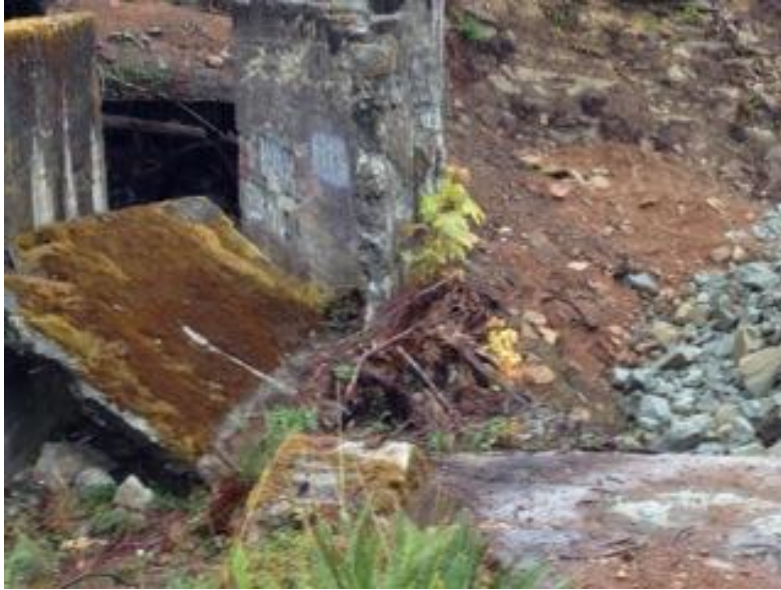
**Collapsed roof slab**
